FACTORY FACTS!

PART A 1963 CORVETTE WITH FUEL INJECTION COLD
STARTING PROCEDURE - CHEVROLET SERVICE NEWS -
VOLUME 35 - JUNE 1963 - NUMBER 6

PART D 1973-1974 CORVETTE ENGINE OVERHEATING PROBLEMS
AND NEW GASKET UNITS FOR MANIFOLD AND CYLINDER
HEADS - CHEVROLET DEALER SERVICE TECHNICAL
BULLETIN - 74-T-6 - 12/5/73

Chevrolet Dealer Service Technical Bulletin	74-T-6 Number: VI Section: Dec. 5, 1973 Date:
Subject: ENGINE OVERHEAT DUE TO BLOCKED COOLANT PASSAGE IN THE CYLINDER HEAD - ALL SMALL BLOCK V-8 ENGINES		Attn: Service Manager

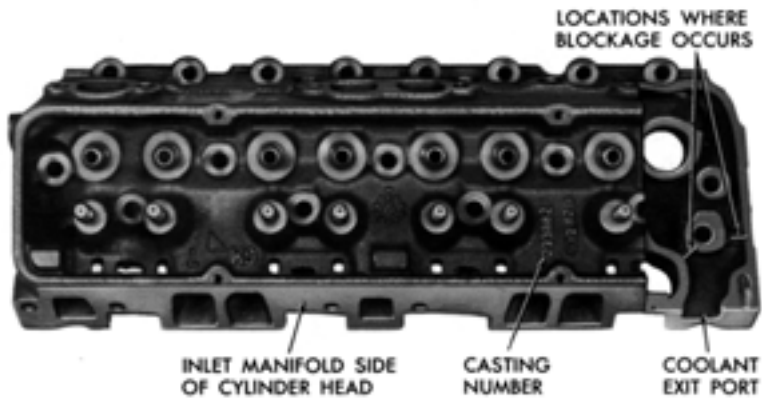
A small number of 350 and 400 cubic inch displacement V-8 engines were built before 9/24/73 (0924) with a coolant blockage in the cylinder head resulting in an overheat condition. A 1974 casting process change has resulted in a possible blockage of the coolant exit port in cylinder head casting No. 333882 (casting number appears on the top of the cylinder head beneath the rocker cover). This cylinder head is common to all 1974 small block V-8 engines, except for those used in C-K30 and 50 thru 60 series trucks.

6. If a blockage is present, it will occur at a depth of approximately five and one half (5-1/2) to six (6) inches from the edge of the thermostat port.

TOP VIEW OF A CYLINDER HEAD PARTIALLY SECTIONED TO SHOW BLOCKED COOLANT PASSAGES

7. The blocked coolant port can be repaired by removing the inlet manifold and knocking out the casting flash in the blocked water passage with a suitable tool. Take care not to damage the oil drain boss. The particles of flashing that fall into the water jacket do not have to be removed. If the blockage cannot be removed, the cylinder head should be replaced.

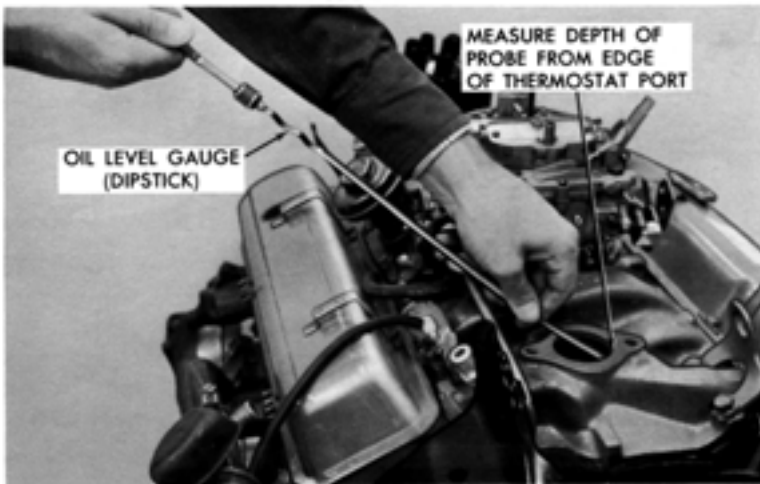
1. Remove the thermostat housing and thermostat.
2. Insert the oil level gauge (dipstick) into the thermostat port thru the inlet manifold coolant passage and into the cylinder head (refer to the illustration on page 3).

3. Work the dipstick into the cylinder head as far as possible by carefully rotating and pushing the handle with one hand while guiding the blade with the other hand.

4. If at least seven (7) inches of the dipstick is inserted past the edge of the thermostat port, there is no blockage.
5. Remove the dipstick and repeat the test for the other cylinder head.

INSPECTION PROBE OF COOLANT EXIT PORT
